[Docket No. 96-CE-35-AD; Amendment 39-10213; AD 97-24-06]

Airworthiness Directives; Glasflugel Models Standard Libelle and Standard Libelle 201 B Sailplanes

97-24-06 GLASFLUGEL: Amendment 39-10213; Docket No. 96-CE-35-AD.

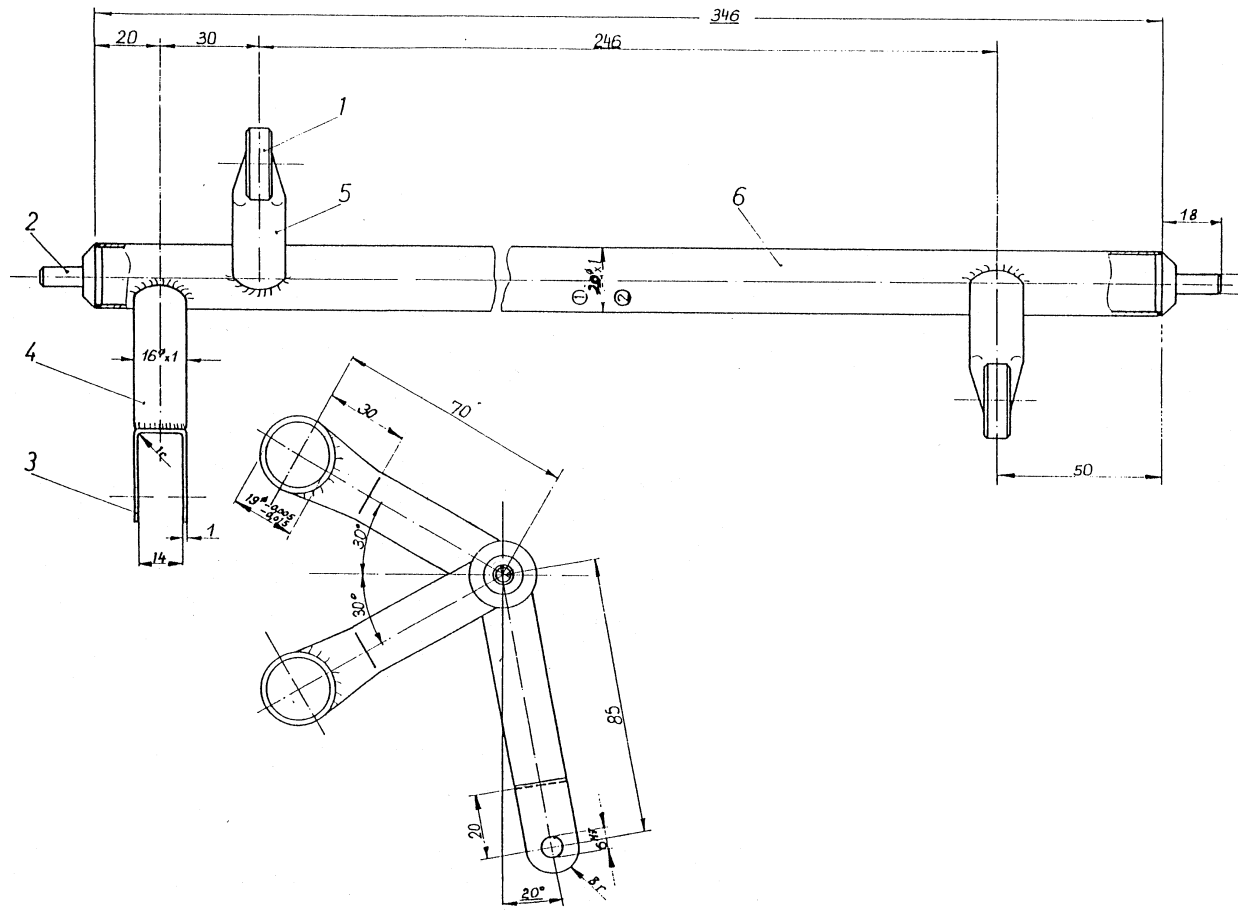
FIGURE 1

Using a magnifying glass (2x minimum) and a flashlight, inspect the aileron actuating shaft in the fuselage (see Figure 1) near the welding seams for cracks in the paint. If there is any cracked paint on the actuating shaft, prior to further flight, remove the actuating shaft and inspect for cracks in the shaft and welding seams using a dye-penetrant method. If there are no cracks or any other damage, flying operation can continue until the accumulation of 8 calendar months after the initial inspection required by this AD, at which time Method 2 or Method 3 shall be accomplished. If cracks are found, prior to further flight, accomplish Method 2 or Method 3.

- (i) Repair any cracked welded seams, and modify the shaft in accordance with Method 2 of the Accomplishment Instructions and Figure 2 in the Appendix of this AD; or,
 - (ii) Remove and replace the shaft with a new Glasflugel reinforced shaft in accordance with Figure 1 and Method 3 in the Accomplishment Instructions in the Appendix of this AD.

As an alternative to Method 2, replace the original actuating shaft with a new reinforced shaft according to Figure 1.
